# Plymouth Engineering, Inc.

Job #: 20033

## Suitability and Conditions Review

Former Corinna Elementary School  
42 Stetson, Corinna, ME.

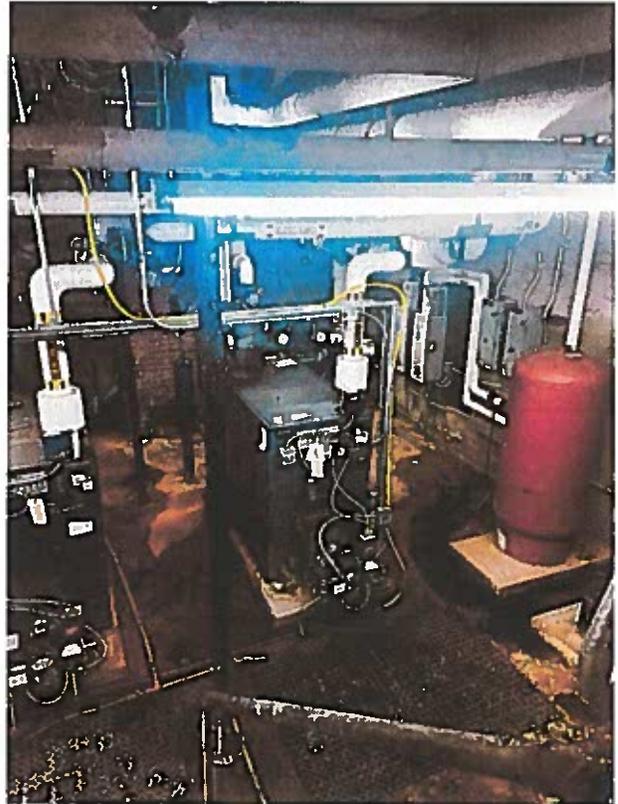
*Photo 2: Mechanical Pit*

- The whole building needs exterior door upgrades and window trim sealing and repairing.
- Boiler room is currently in a 16' pit with sprinkler equipment. It is highly recommended to bring the boiler to grade due to the recurrence of water in the pit and the consistent humidity.
- Elementary sign out front will need to be changed/removed.
- Hood and sprinkler inspections will need to be performed yearly.

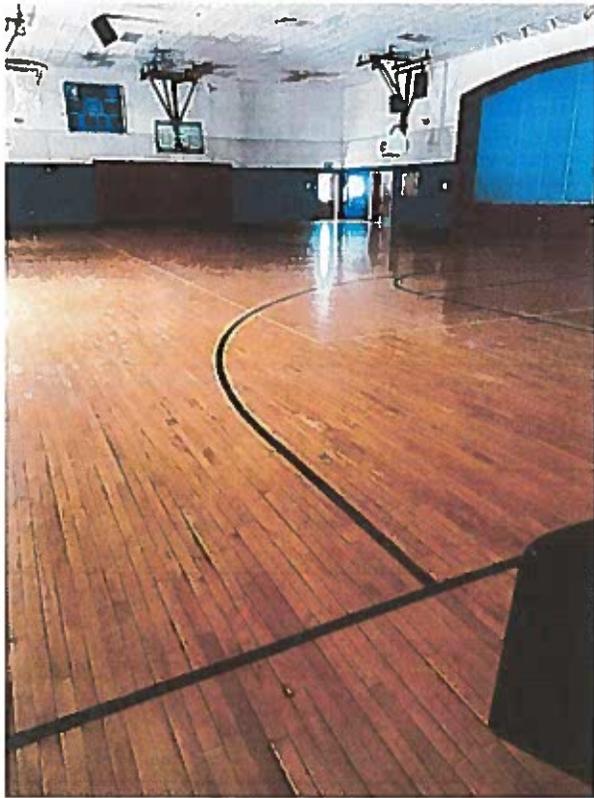
*Photo 4: Addition Gym*

- The addition consists of a gym, stage, library, 5 classrooms and mechanical room access.
- Gyms ceiling tiles are in poor condition and will need to be replaced in the future and cleaned soon.
- Cosmetics upgrades are needed, such as painting, window sealing and trim work.
- The carpet on the floors will likely need replacing.

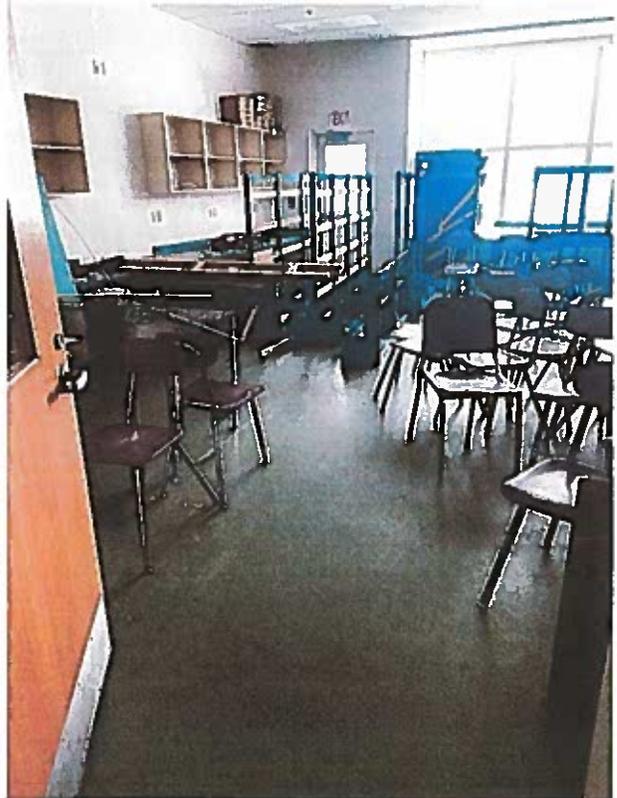
*Photo 3: Science Room*

The science lab has a great potential to be a daycare. It has its own access to the playground and parking lot. The ACT will need to be replaced in this room in three years and will need two of its closets converted into bathrooms.

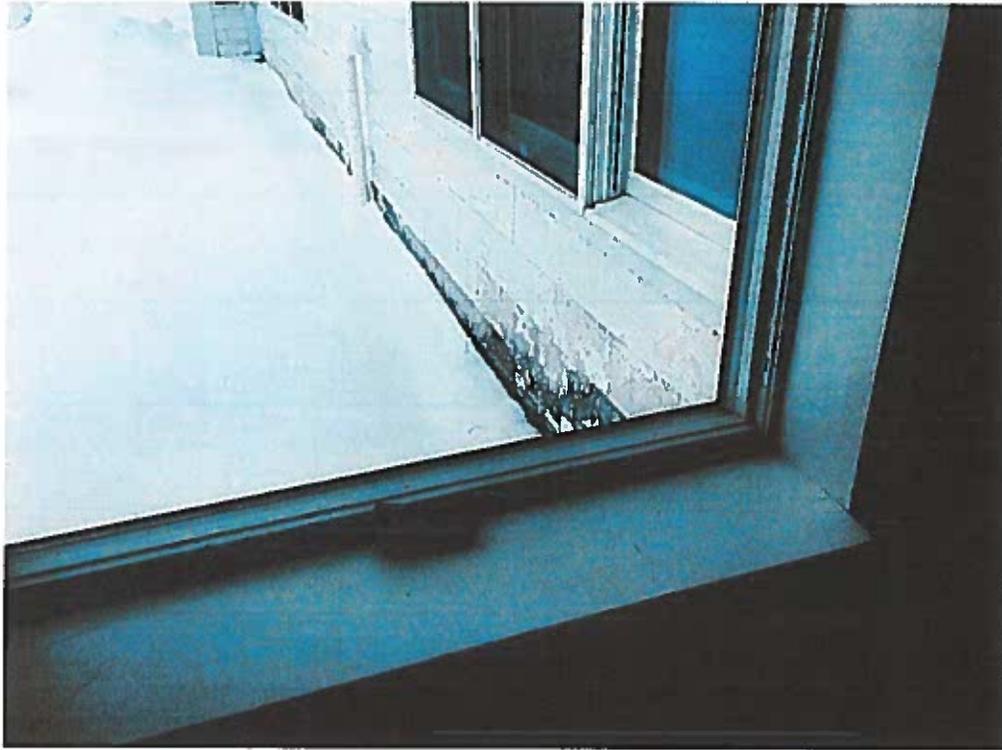
*Photo 5: Masonite Exterior Siding*

- The Masonite siding is in poor condition and is recommended to repair in the near future.
- There is a total of 8 exits and entrances, not all doors were clear to open, but the doors will need to be updated.
- Due to the weather, a detailed inspection was unable to be performed on the roof. PEI would recommend doing an inspection when the roof can be accessed for an in-depth review. The front of the building had curling shingles visible.
