# Plymouth Engineering, Inc.

Job #: 19211

## Suitability and Conditions Review

Existing Commercial building  
14 Fernald Avenue, Corinna, ME.

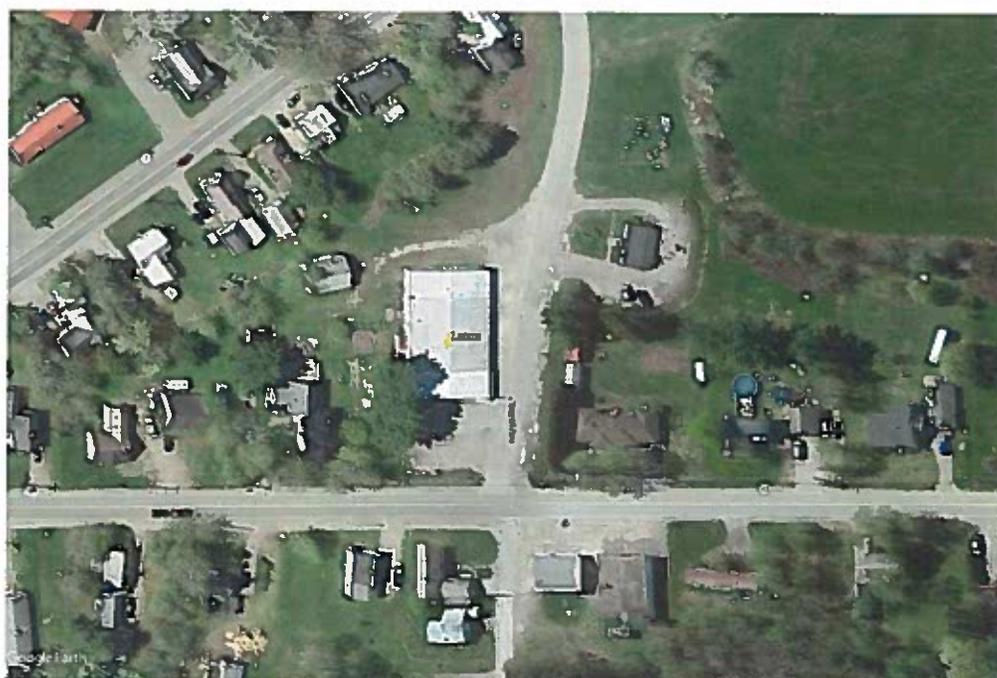
**Aerial View**

- Aerial views of the building depict a corrugated metal roof in fair condition. No obvious leaks were observed from the interior of the building.

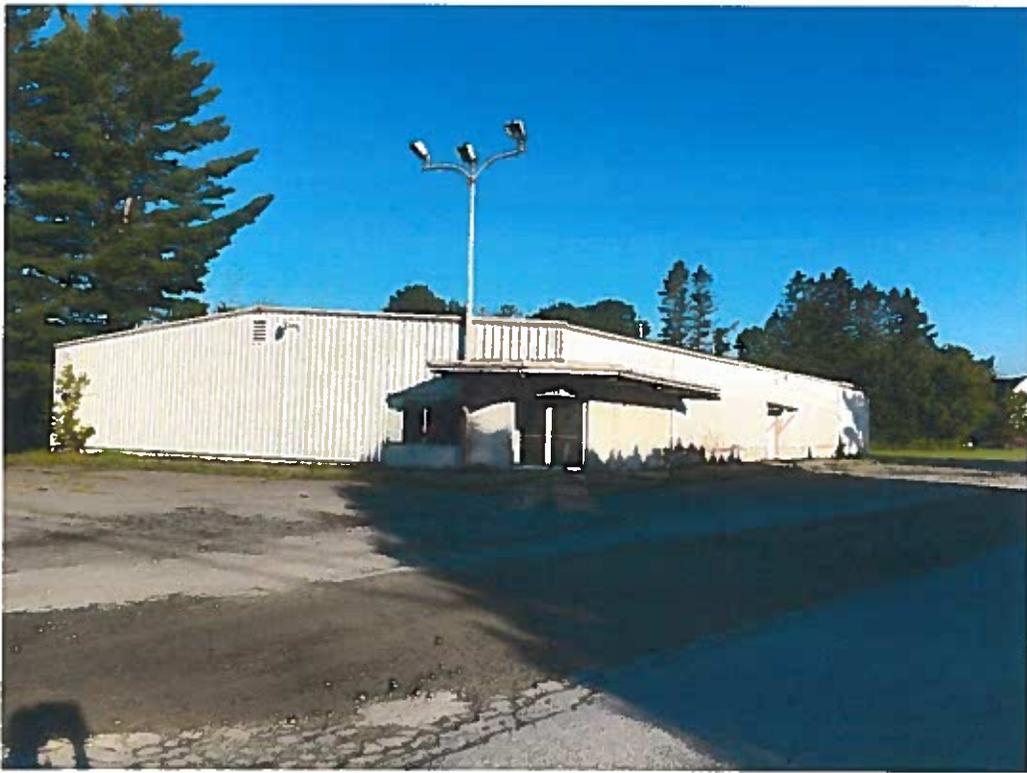
**Front / Left corner  
(entrance)**

- The metal siding appears to be corrugated siding with paint in poor condition.
- The main entrance is typical store front type in average condition, an overhead and man door in the rear in very poor condition and one other man door.
- An awning exists on the front left of the building sheltering the entrance.
