# Plymouth Engineering, Inc.

Job #: 20033

## Suitability and Conditions Review

Former Corinna Elementary School  
42 Stetson, Corinna, ME.

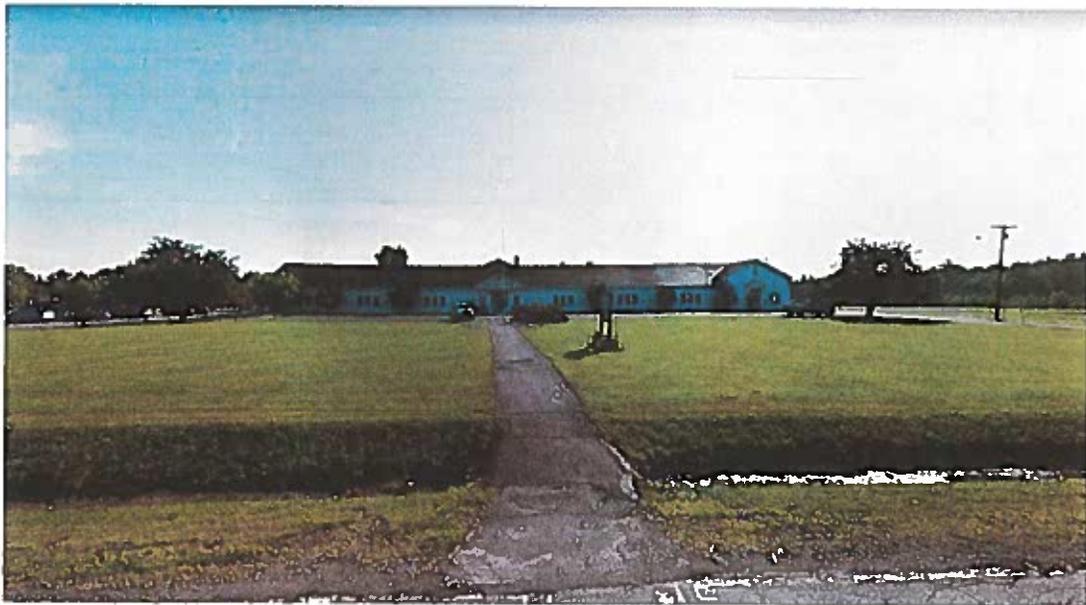
**Front  
(Entrance)**

- The Masonite siding is in poor condition and is recommended to repair in the near future.
- There is a total of 8 exits and entrances, not all doors were clear to open, but the doors will need to be updated.
- Due to the weather, a detailed inspection was unable to be performed on the roof. PEI would recommend doing an inspection when the roof can be accessed for an in-depth review. The front of the building had curling shingles visible.

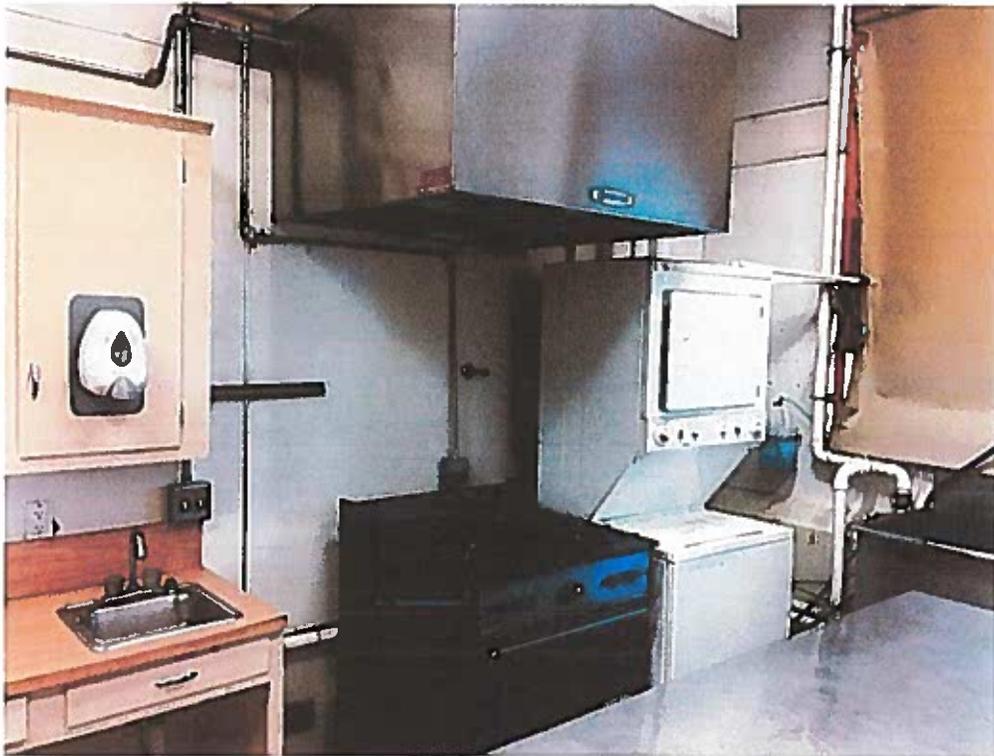
*Photo 8: Kitchen*

- The whole building needs exterior door upgrades and window trim sealing and repairing.
- Boiler room is currently in a 16' pit with sprinkler equipment. It is highly recommended to bring the boiler to grade due to the recurrence of water in the pit and the consistent humidity.
- Elementary sign out front will need to be changed/removed.
- Hood and sprinkler inspections will need to be performed yearly.
